**PRITCHARDS POND DAM  
CT 00033**

**NAUGATUCK RIVER BASIN  
WATERBURY, CONNECTICUT**

**PHASE I INSPECTION REPORT  
NATIONAL DAM INSPECTION REPORT**

Re: Pritchards Pond Dam  
Waterbury, Connecticut  
Contract #DACW-33-81-C0017

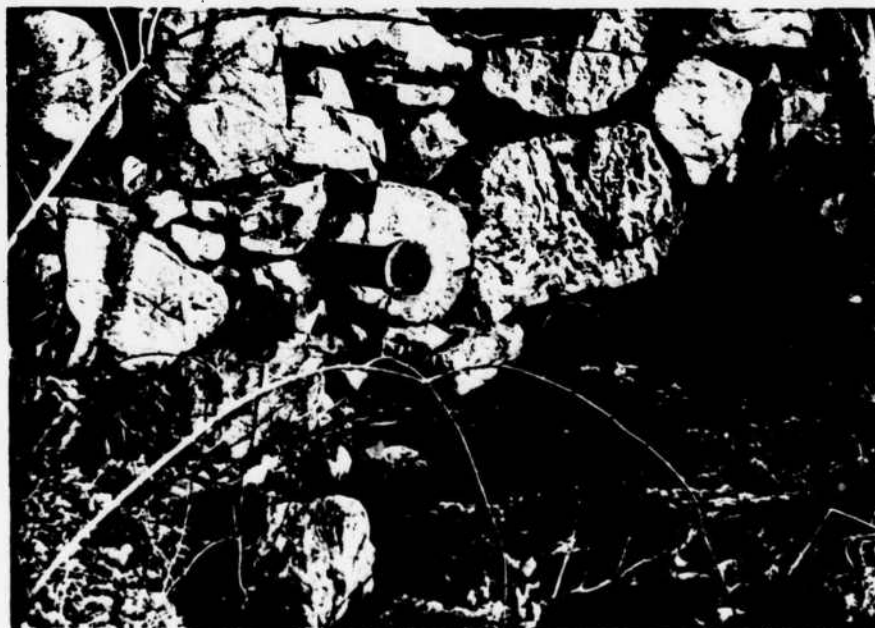
6. Spillway and outlet discharge pipes.

Wet area and minor seepage observed on left floodplain about 50 ft. downstream of embankment. Minor seepage from stone masonry wall, adjacent to outlet pipe.
